CHASMARS POND DAM CT 00059

PHASE I INSPECTION REPORT NATIONAL DAM INSPECTION PROGRAM

MAY 1981

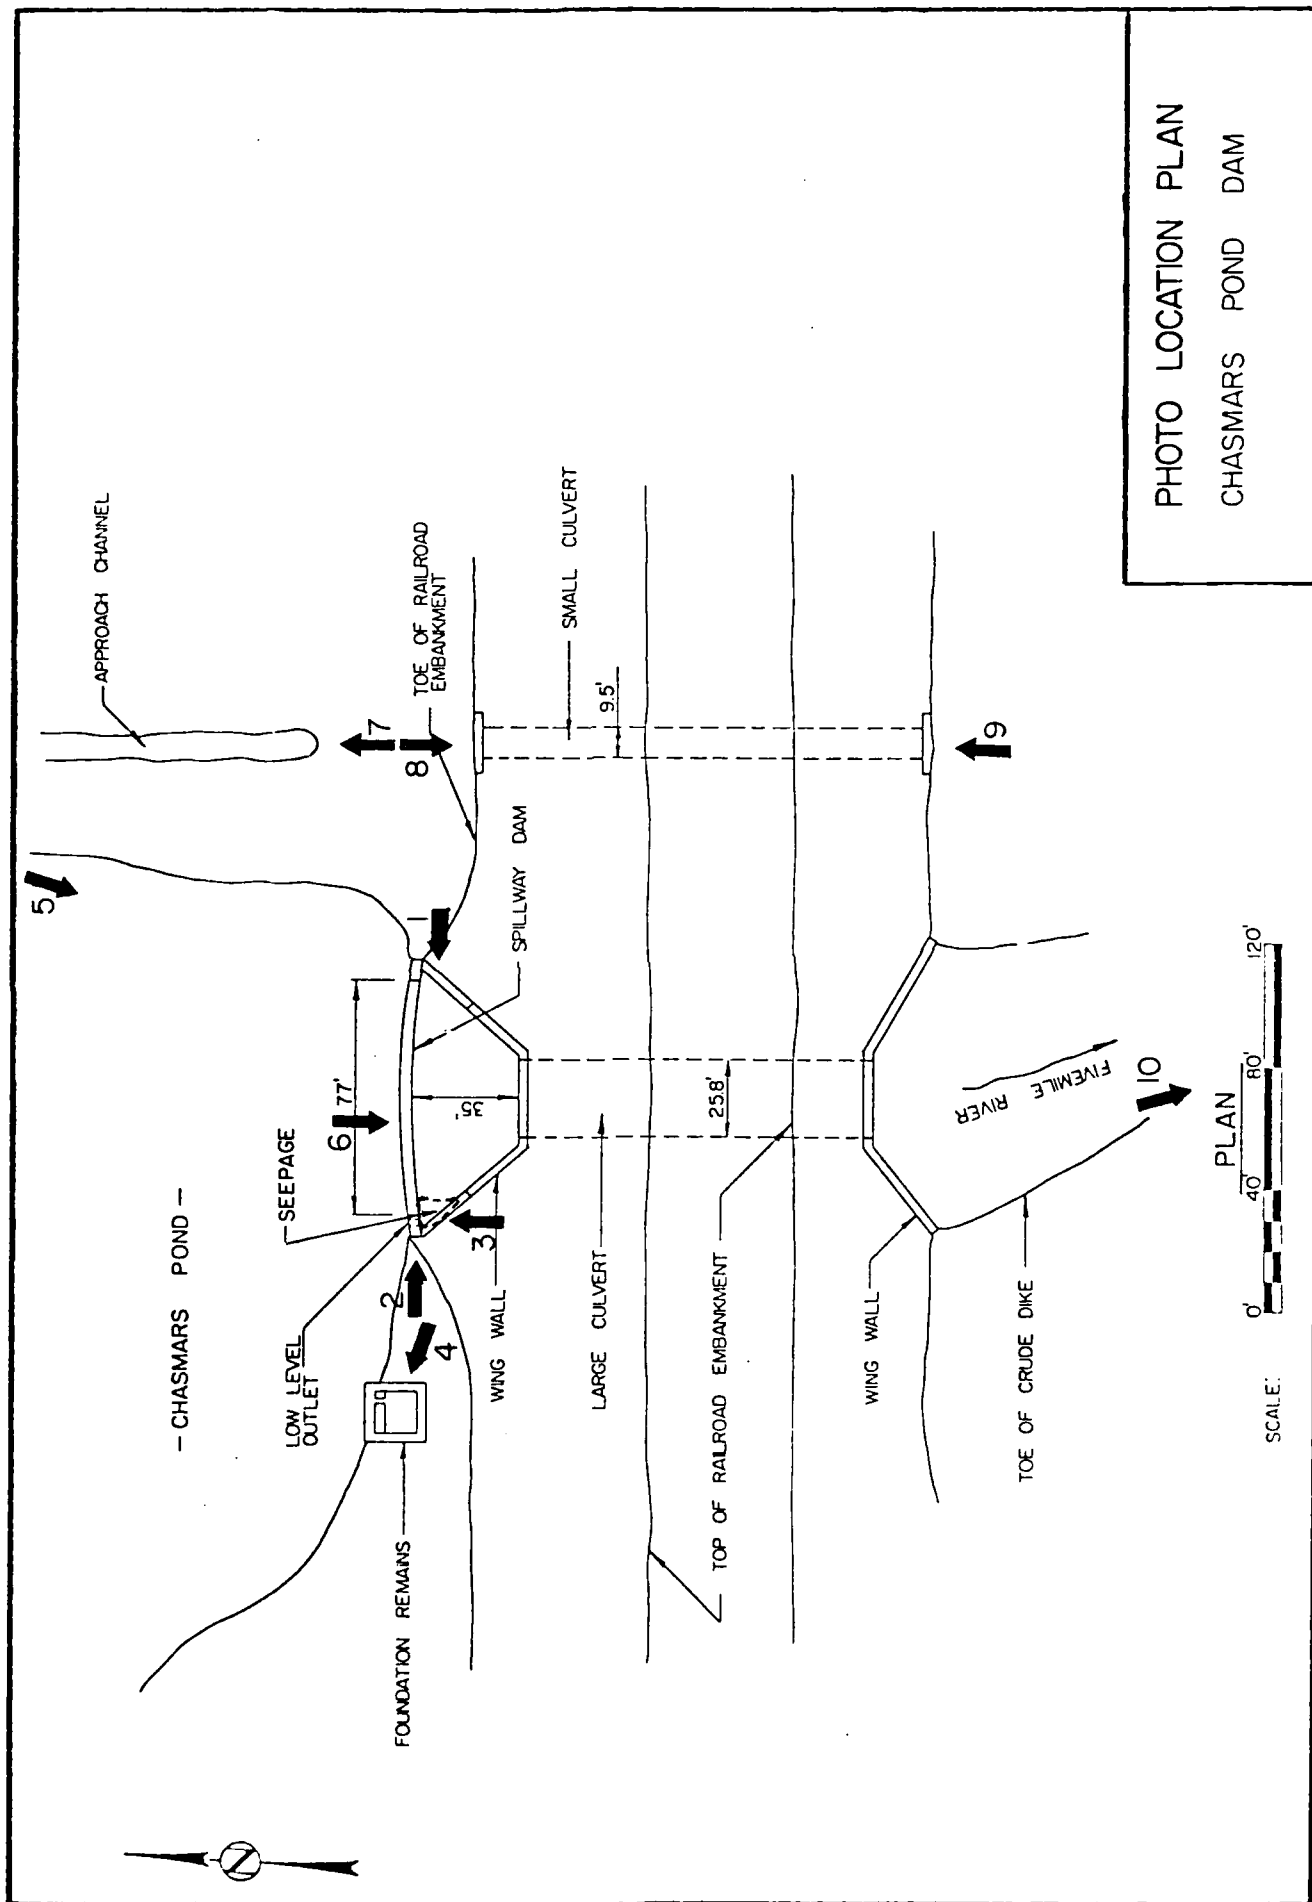
b. Dam — The dam is a masonry overflow structure. Flow over the structure hindered the inspection, in that the downstream face of the spillway dam could not be closely examined. However, the stone blocks on the crest and on the downstream face appeared to have maintained their original alignment (Photos 1 and 2). Despite the deterioration of the mortar joints on the downstream face of the spillway dam, there was only one stone block missing at the crest of the spillway near the left abutment.

The masonry wing walls (Photos 1 and 2) form a transition channel between the dam and the railroad culvert. No signs of bulging or settlement of the walls were noted; however, a small, immeasurable amount of seepage was observed emanating from the mortar joints. In addition, several trees ranging from 2 to 8 inches in diameter and patches of brush were noted overhanging the transition channel.

There was a slight accumulation of debris on the spillway dam and in the transition channel (Photos 1, 2 and 3). In addition, several trees overhanging the transition channel were noted near the wing walls and above the large masonry culvert.

Photo 1 Dam, right wing wall at abutment, and transition channel.
